Technical Service Information

VW/AUDI, 01M, 01N, 01P UNCONTROLLABLE HARSH 1-2 UPSHIFT

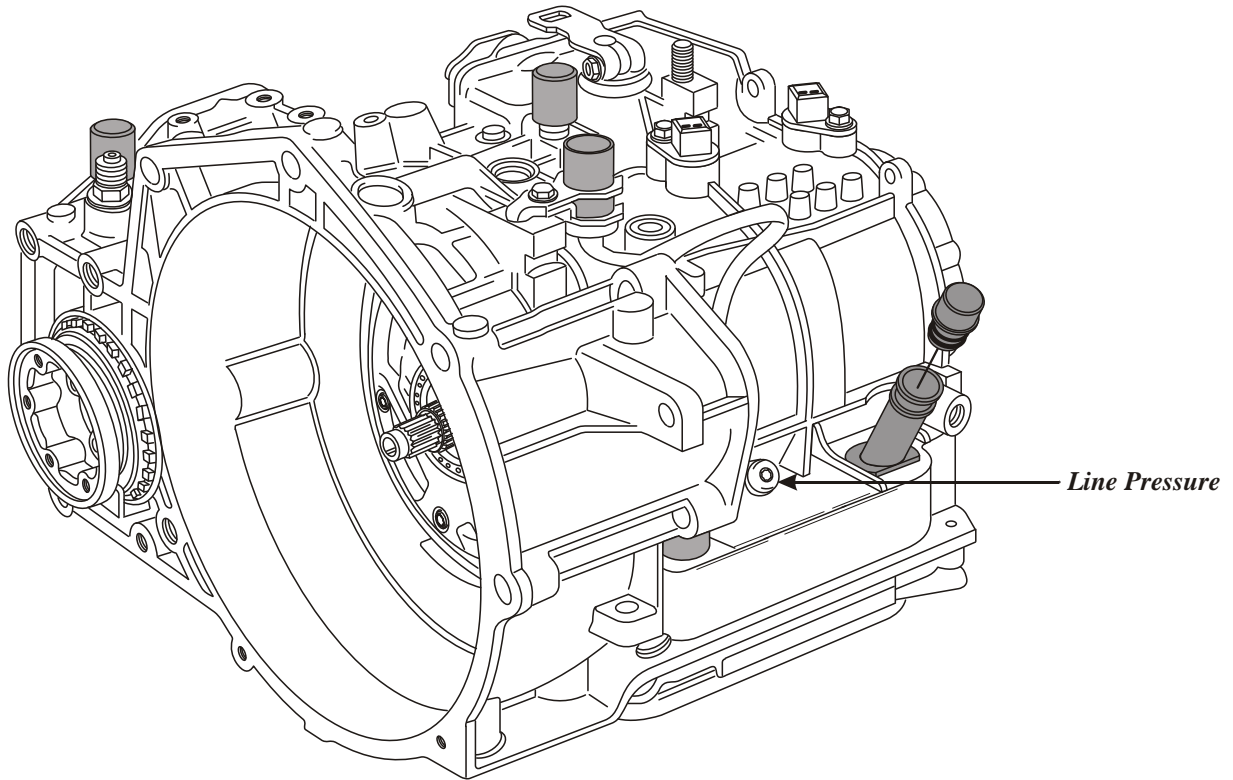
Figure 1

***LINE PRESSURE SHOULD INDICATE 60psi. AT IDLE IN DRIVE
LINE PRESSURE WILL INCREASE TO BETWEEN 120-150psi. AND
SHOULD CUT BACK TO 65-75 ON EACH SHIFT***

1. Connect a pressure gage to the line pressure port as shown in Figure 1. Line pressure should indicate 60 psi. in the Drive position at idle and should increase to 120-150 psi. at stall. Line pressure should cut back to between 65-75 psi. on each shift. If Line pressure does not cut back on each shift, or is at 120-150 psi. at all times, or is erratic on the gage, replace the EV6 solenoid and check the Boost Regulator and Main Regulator valve to ensure they are not stuck. Refer to Figure 2 for a description of how EV6 Solenoid operates.
2. Refer to Figure 5 and locate terminal 7 at harness connector. Back probe that terminal to verify that the computer is grounding EV5 during the 1-2 upshift. If the computer is not grounding that terminal, go to STEP A. If the Computer is grounding that terminal go to STEP B.

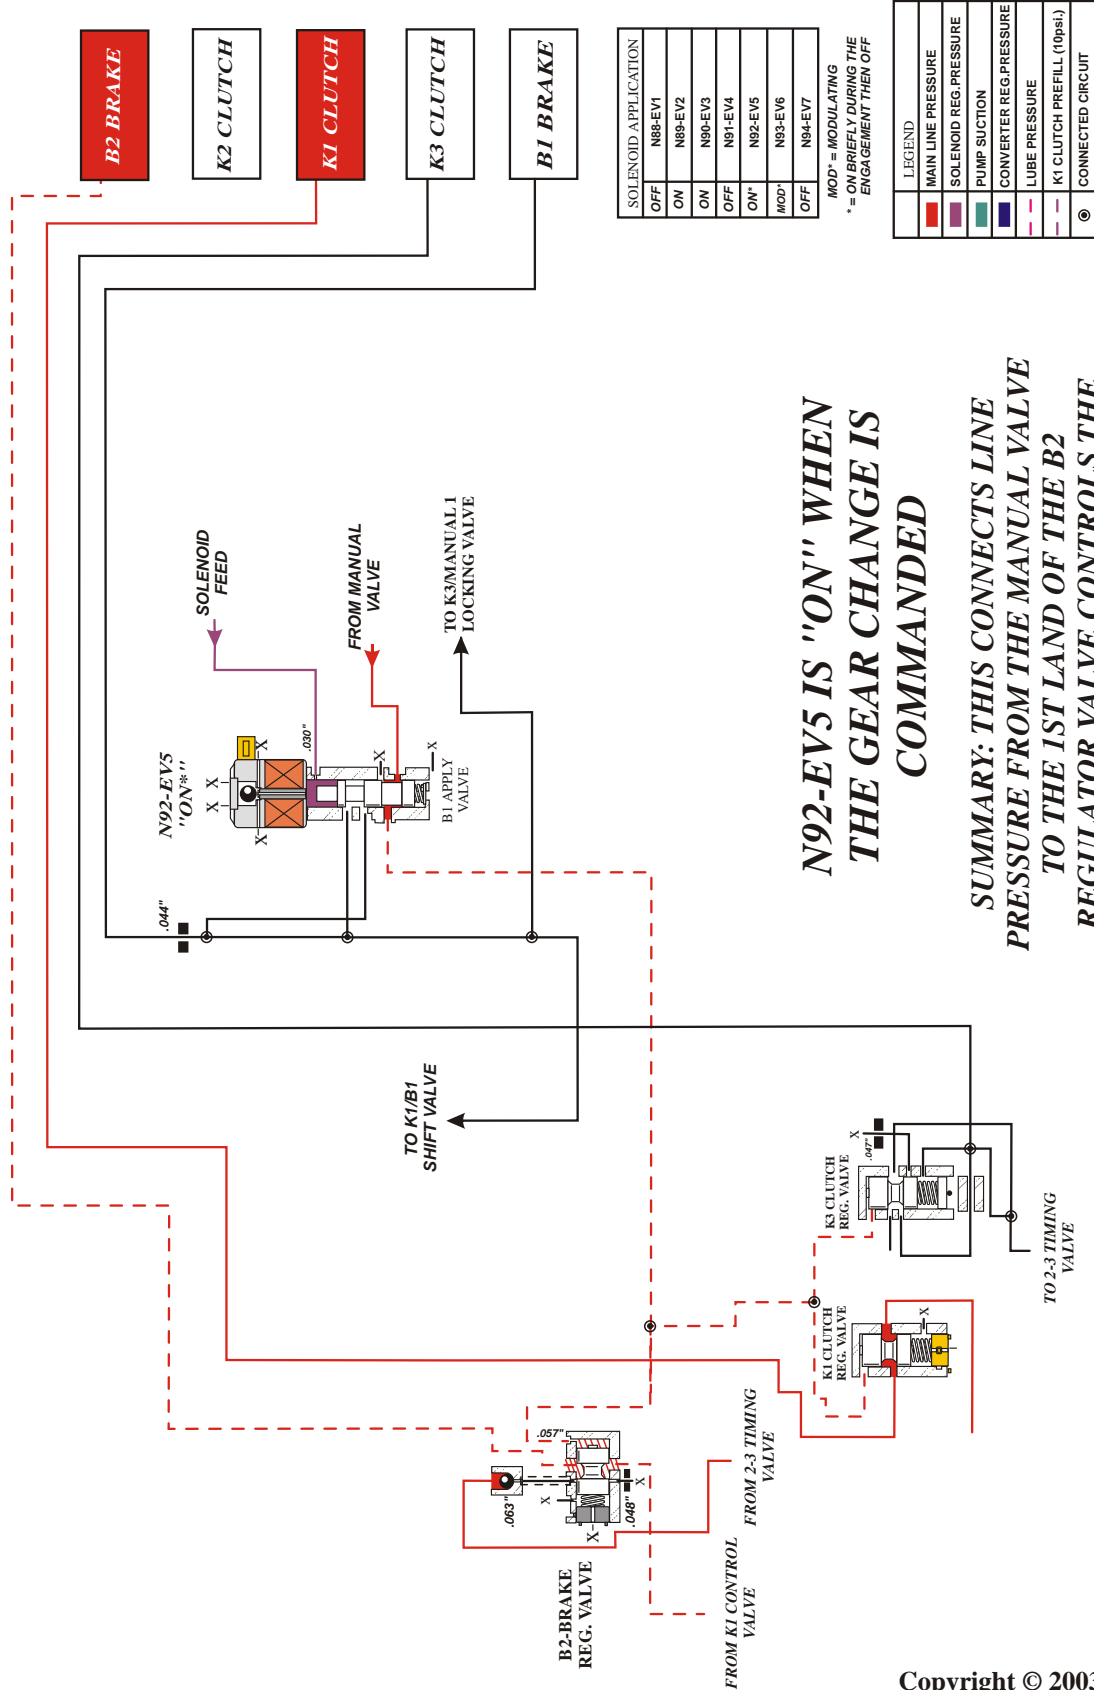
Figure 3

(NOTE: The EV5 solenoid is grounded on each engagement and each upshift and downshift which helps control Clutch apply Pressure for smooth engagements as shown in Figures 3 and 4.)

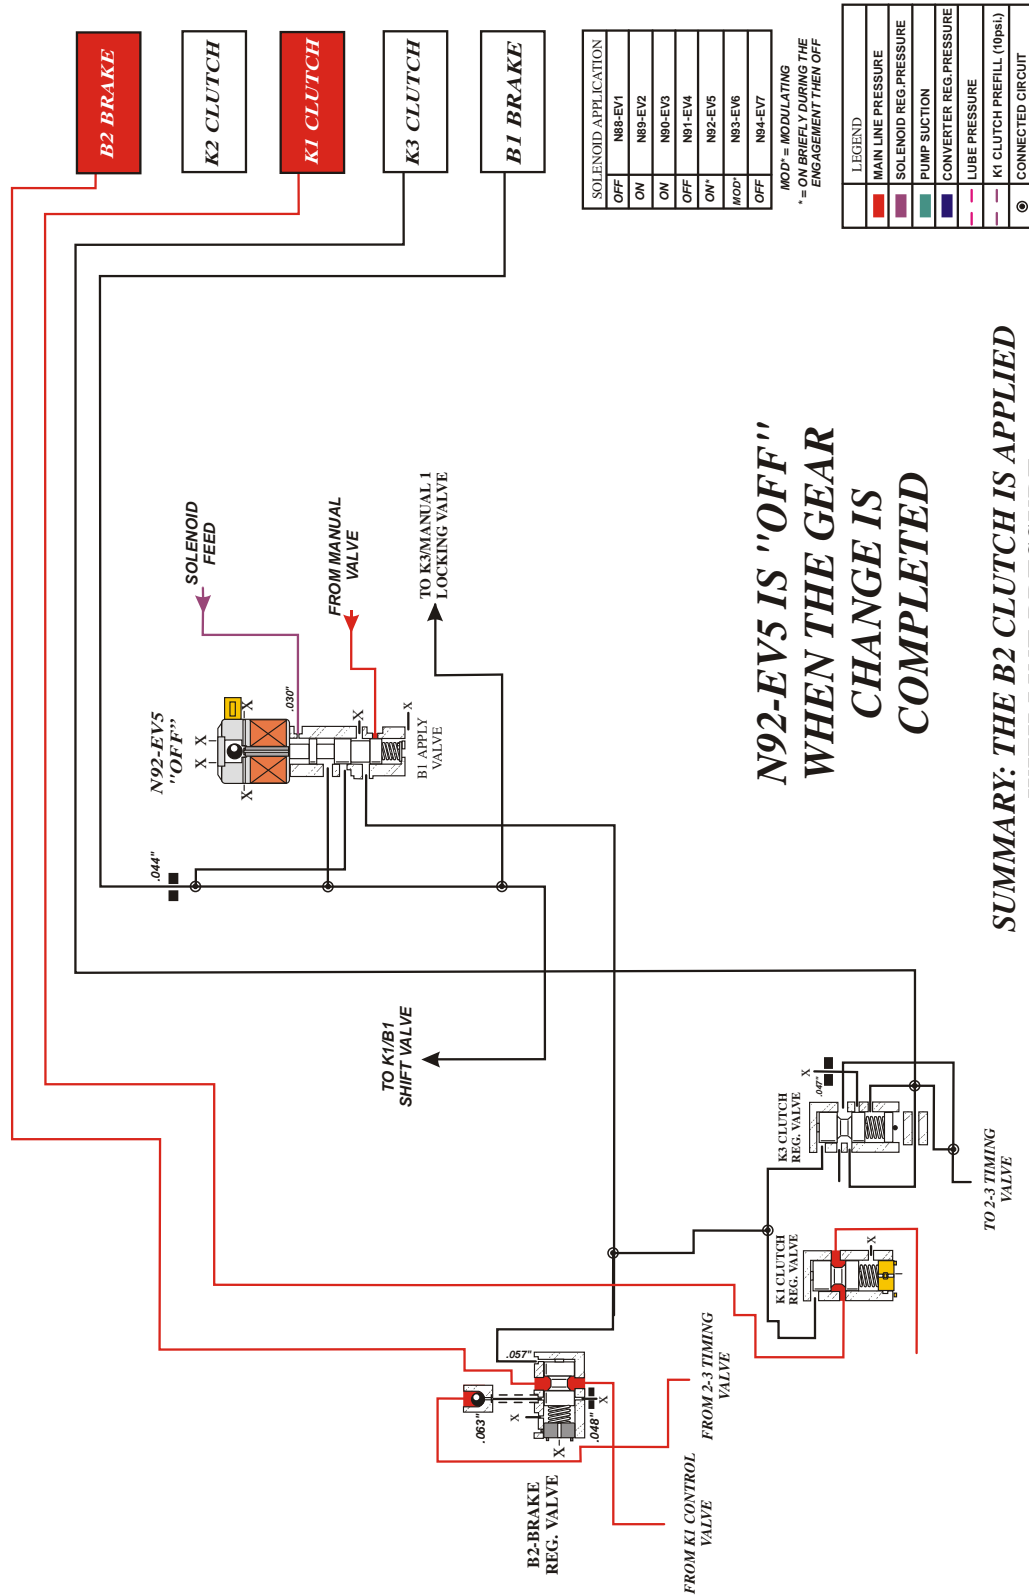
Figure 4

N92-EV5 IS "OFF" WHEN THE GEAR CHANGE IS COMPLETED

SUMMARY: THE B2 CLUTCH IS APPLIED WITH LINE PRESSURE

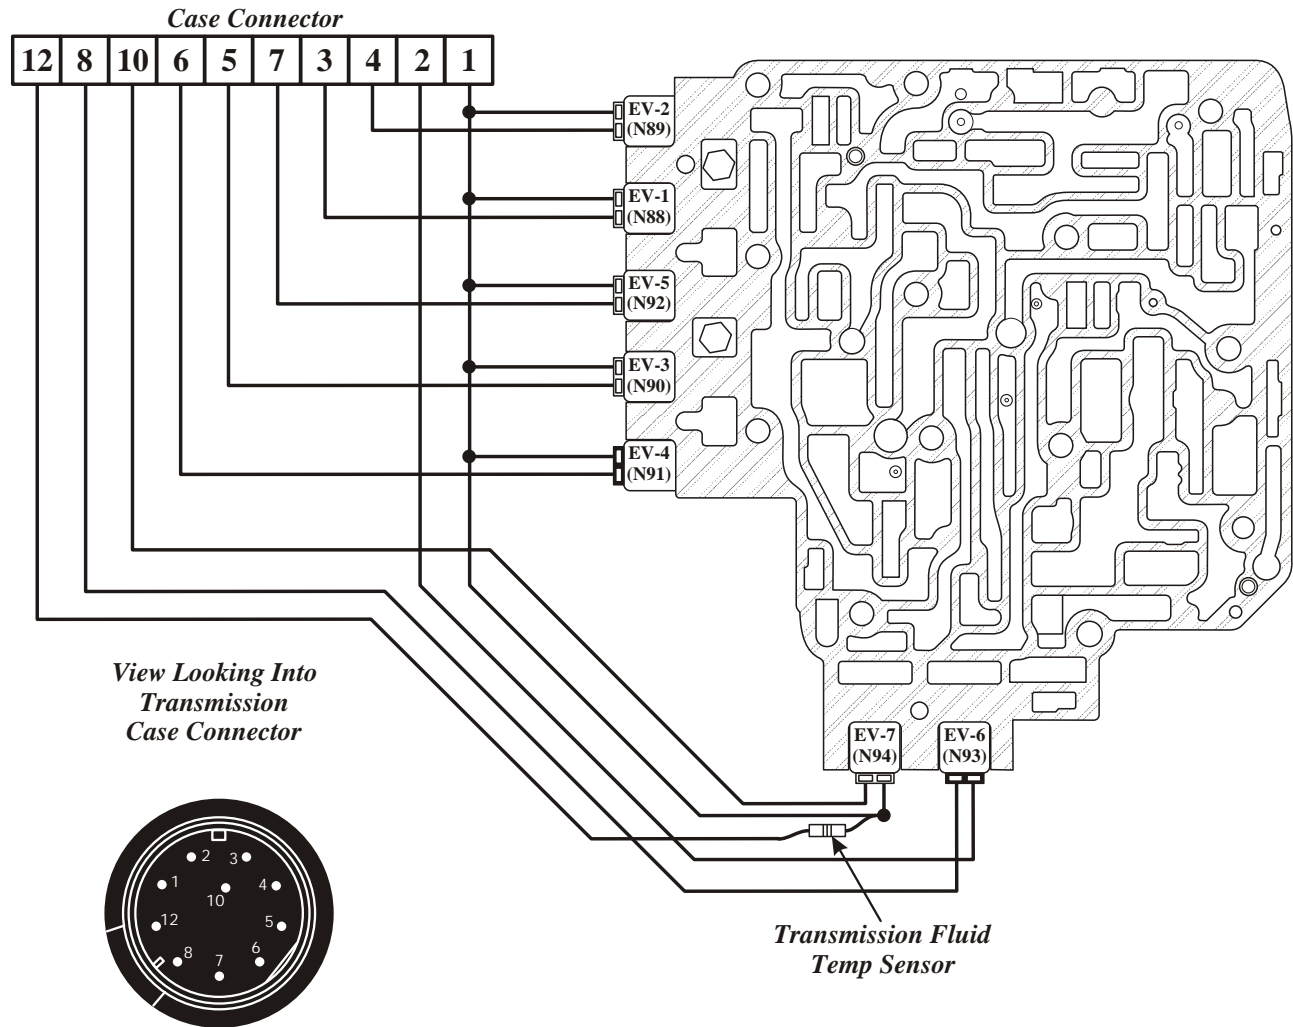
Figure 5

**BACK PROBE
THIS TERMINAL**

STEP A. Connect a scan tool to the diagnostic connector and check to see if the TCM has set a trouble code 00266 (VAG) or a P0773 which are EV5 solenoid circuit faults. Repair the EV5 Solenoid circuit as needed. If the TCM has no trouble codes set and does not ground EV5 Solenoid during the 1-2 shift, the TCM may be faulty.
