Technical Service Information

VW/AUDI, 01M, 01N, 01P UNCONTROLLABLE HARSH 1-2 UPSHIFT

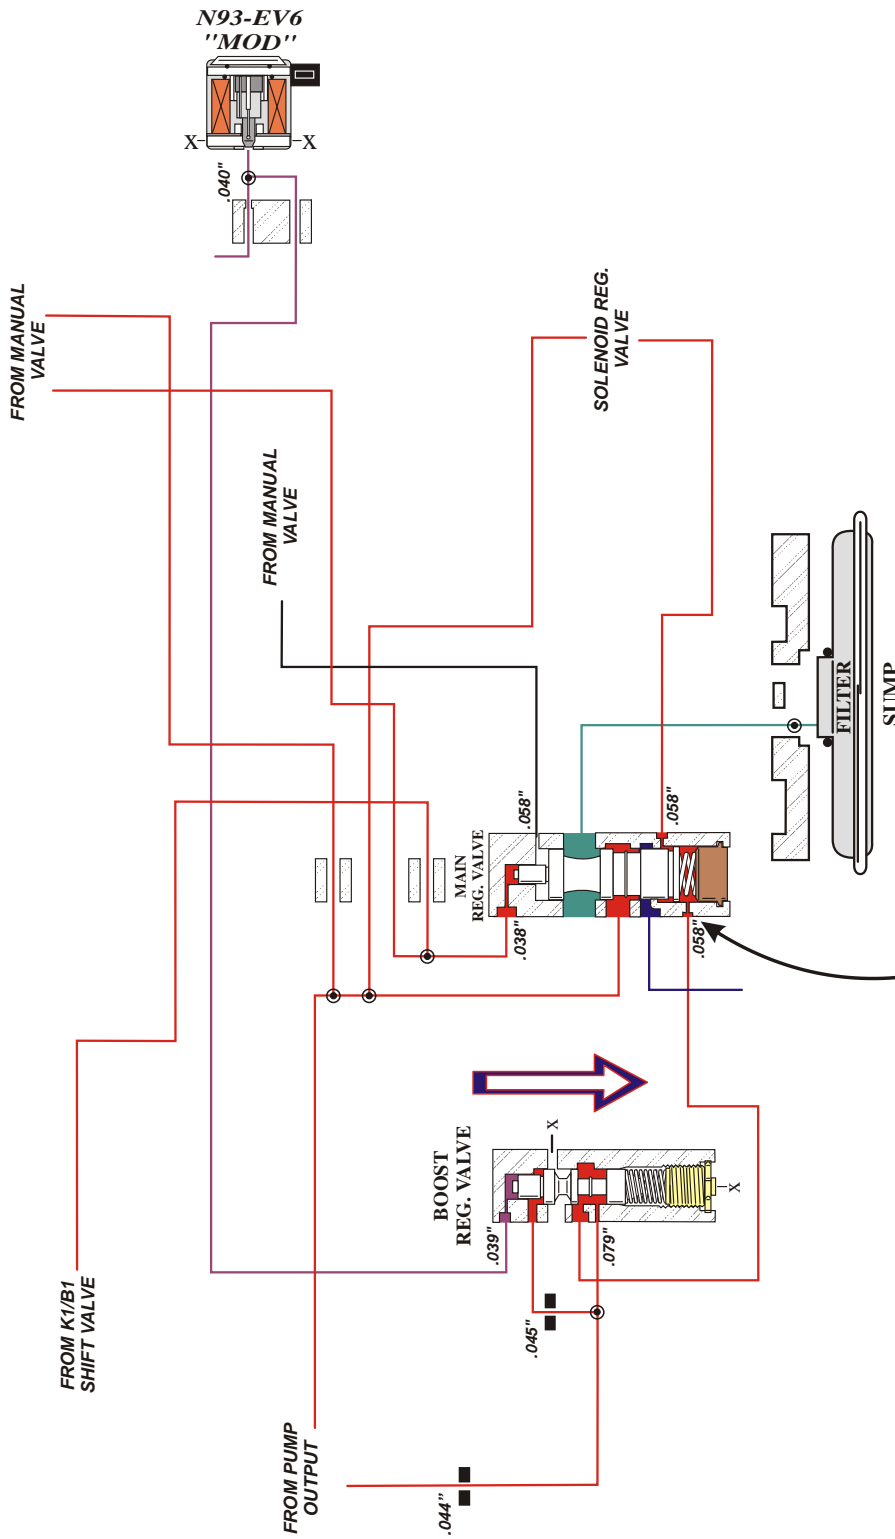
Figure 2

"01M" N93-EV6 OPERATION

N93-EV6, WHEN MODULATING, STROKES THE BOOST REGULATOR VALVE AGAINST ITS SPRING, REDUCING THE AMOUNT OF BOOST PRESSURE ON THE SPRING SIDE OF THE MAIN REGULATOR VALVE.
